# HISTORIC COOPERSBURG DESIGN GUIDELINES

RESTORING, MAINTAINING, AND PRESERVING THE  
HISTORIC CHARACTER OF COOPERSBURG

BOROUGH OF COOPERSBURG, PENNSYLVANIA

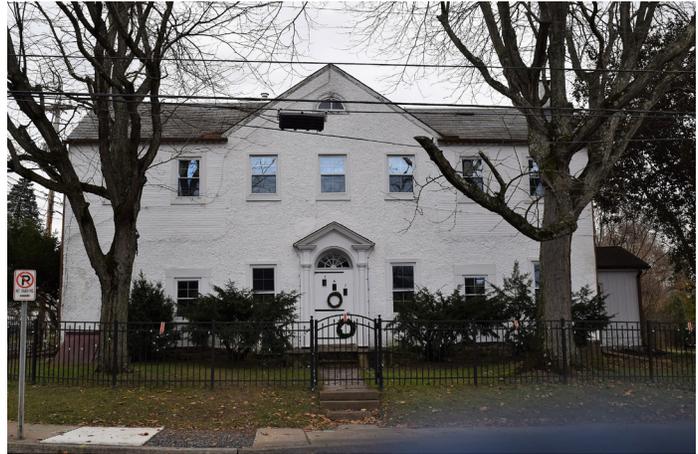
During the period of early settlement in the mid-18th century, the first buildings constructed were small, rectangular stone houses, sometimes stuccoed, with stone chimneys and gabled roofs, often with dormers. Houses often exhibited simple colonial architectural features, including flat arched windows with understated keystones. Other examples of the earliest buildings dating from the 1770s-80s in the Historic District included stone taverns and hotels, which welcomed a growing local population and travelers, such as the former Conrad Star's Tavern at Main and Fairmount streets.

Originally Conrad Star's Tavern, c. 1740, altered colonial style

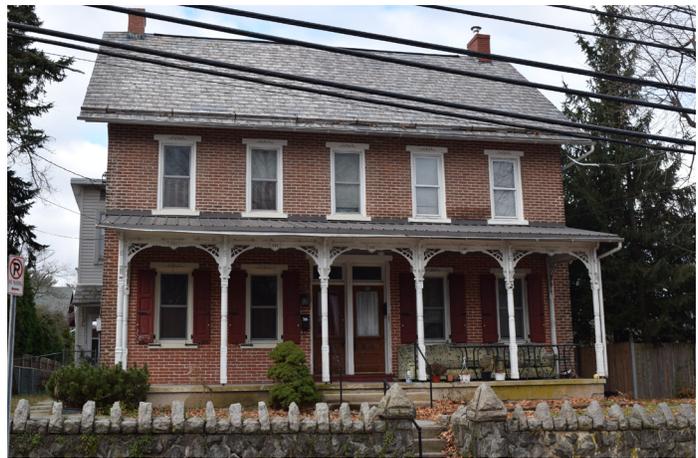
Typical vernacular brick row home in Coopersburg

Also prevalent in Coopersburg's downtown is the vernacular brick rowhome (1880s-90s). Two to three stories and constructed of brick, these working-class, multi-family residences were typically constructed in groups of two to four and consistently featured roofed front porches, tall windows, rectangular massing, a gable roof, and minimal architectural detailing.

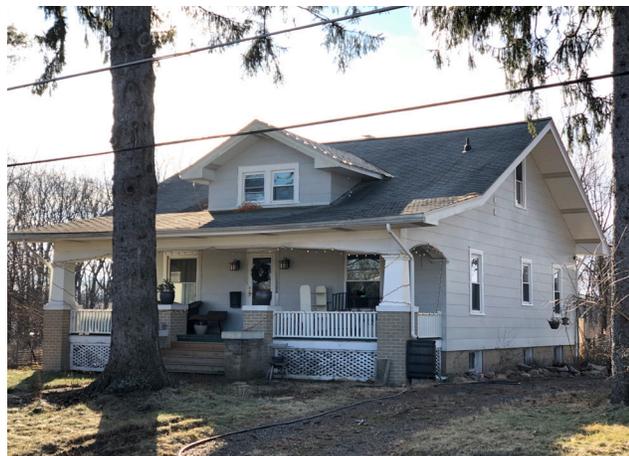
The early 20th century saw the rise of the Craftsman style across the country. These typically one or two story, wood-constructed residential cottages typically feature a low-pitched gable roof, overhanging eaves, exposed rafters, horizontally-oriented massing, and often a veranda or roofed front porch.

Craftsman Bungalow residence on State Street

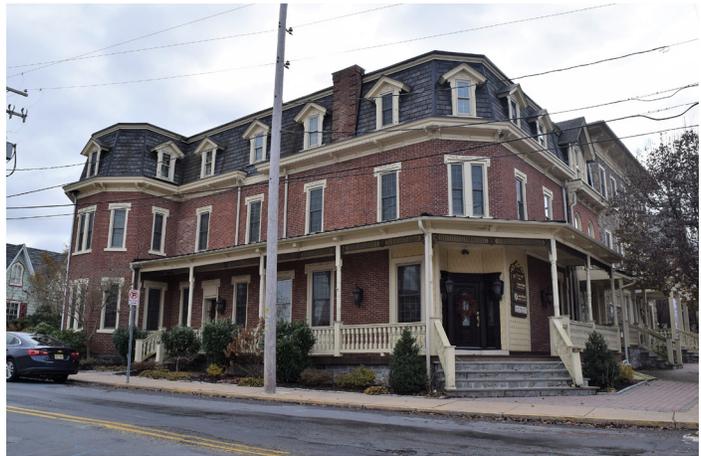
Corner property on Main Street with two primary facades

The parameters described in these Design Guidelines aim to advise changes made to any historic building facade which is visible from a public right-of-way. Facades are categorized as primary and secondary. Facades that are visible from a public street and which include the front entrance or historically significant architectural features, are considered primary facades. Corner properties have two primary facades. Facades that are considered the rear of a building, do not exhibit significant architectural features, and are not highly visible from a primary or major street are considered secondary facades.

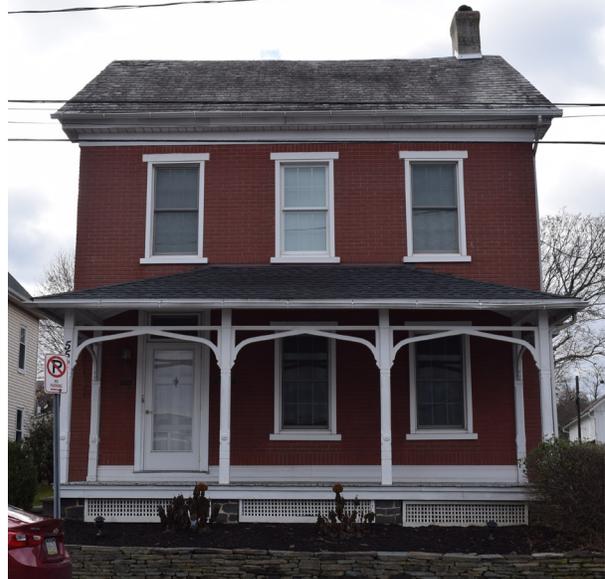
A traditional brick masonry facade

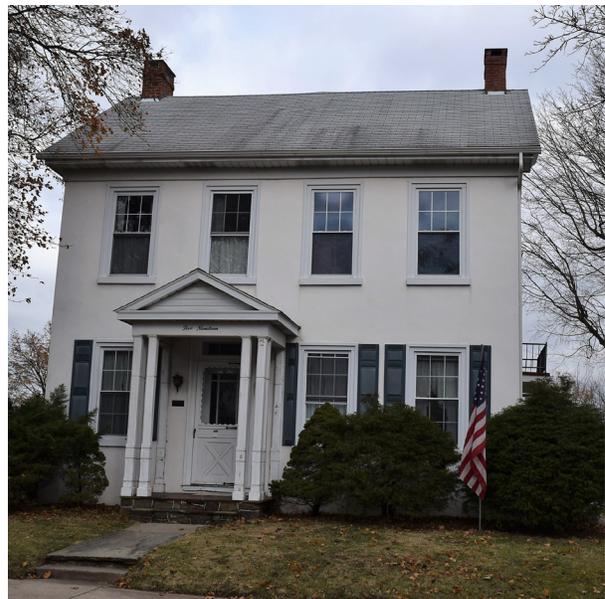
A cleaned stucco facade

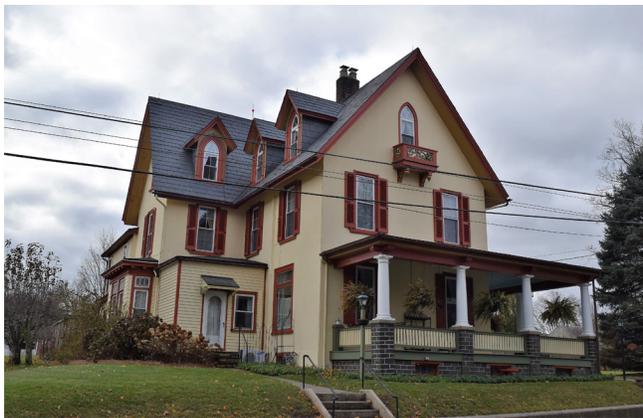
Restored stucco exterior with wood trim

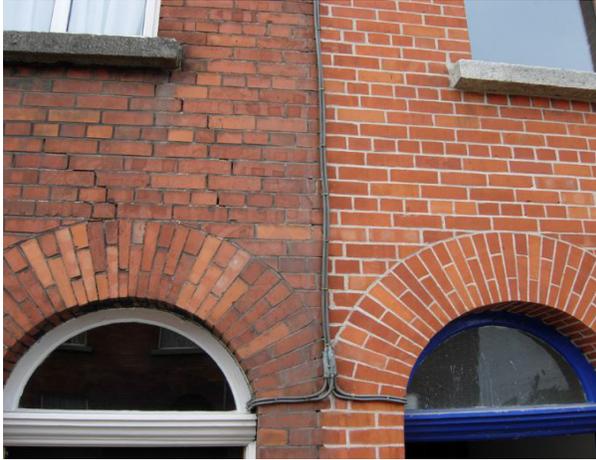
Before (left) and after (right) repointing and cleaning of historic brick

- ✔ Mortar used for repointing historic masonry should be of the proper mortar type, hardness and mixture
- ✔ New mortar joints should match the old in style, color, and texture
- ✔ It is recommended to use a high lime mortar: 1 part hydrated lime with 2 parts (by volume) sand of appropriate historic color, water to mix; To improve workability/drying, some Portland cement can be added (should not exceed 20% of the volume of lime and cement combined)
- ✘ Mortar mixtures which contain a high Portland Cement content are too hard and can cause significant damage to historic masonry.
- ✘ New joints should match the width of existing joints and should not cover areas of the existing masonry bricks
- ✘ Grinders should not be used to remove old mortar. Grinders can cut into brick and enlarge joints inappropriately

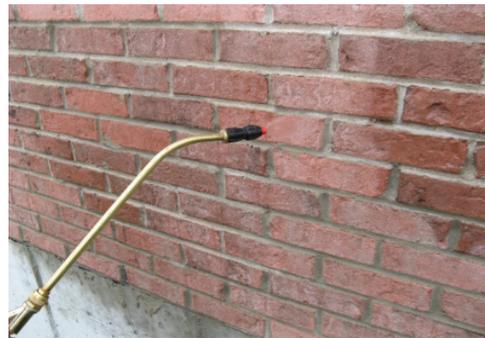
Spray sealant (right side)

Sealing historic masonry including brick and stone walls with clear sealants and water repellents is not recommended. Sealing historic masonry can trap moisture and lead to deterioration of the masonry. Water absorption is not normally a problem in a well maintained and properly pointed masonry wall. If masonry is not well maintained, sealers cannot solve an infiltration problem. In most cases, repointing and replacing damaged masonry is the best remedy for a wall.

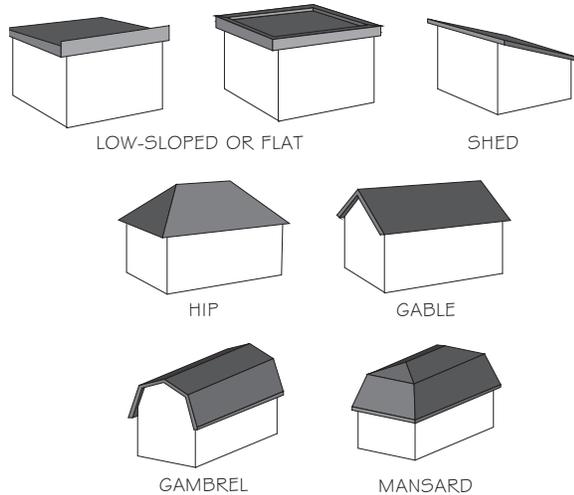
Typical roof types (Courtesy of Artefact Inc.)

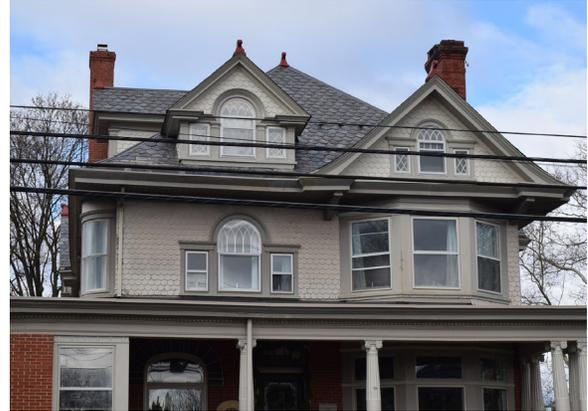
A cross-hipped roof with slate shingles and dormers.

The most cost-effective and appropriate way to preserve a slate roof is through regular maintenance. After each winter, a slate roof should be inspected and cracked, broken, or missing slates be replaced. This is generally a relatively inexpensive project to undertake if done on a yearly basis.

✓ Replacement of deteriorated slate shingles with new slate shingles through regular maintenance is recommended

⚠ Replacing slate shingles with asphalt shingles on a gable or hipped roof is not recommended, but may be acceptable when the slate or fasteners have reached the end of their serviceable life.

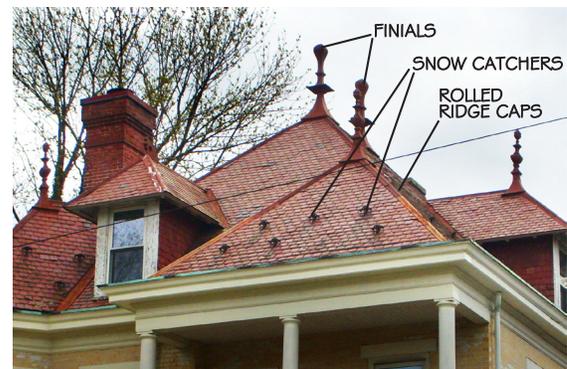
Red slate roof with rolled ridge caps, finials and snow catchers

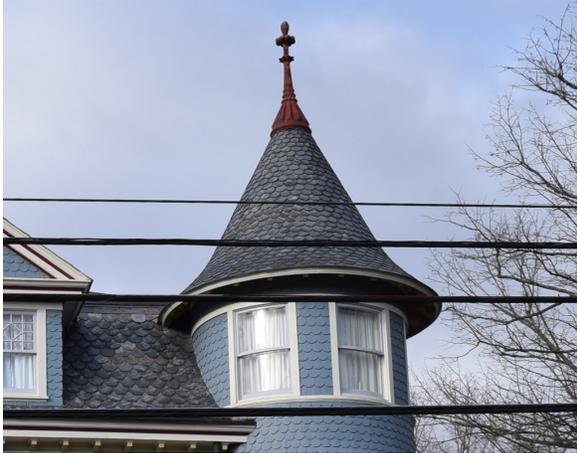
Unique tower roof with slate shingles and finials

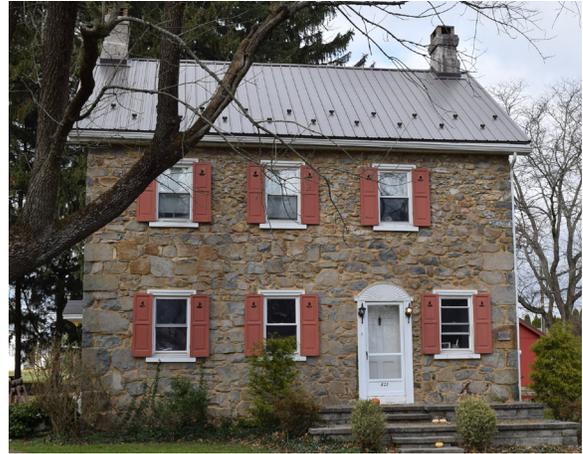
Replaced standing seam metal roof

⚠ Use of modern pre-formed standing seam metal roofing may be acceptable. Trim pieces required in some pre-formed metal roofs can be inappropriate in terms of scale

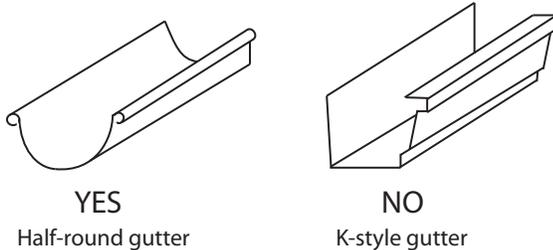
Typical gutter designs  
Courtesy of Artefact Inc.

- ✔ Built-in box gutters must be preserved. Box gutters should be relined with new metal or an appropriate roofing membrane to eliminate leaks that will damage historic wood cornice materials.
- ✘ K-style gutters are not historically appropriate and are not permitted.
- ✘ PVC or vinyl gutters or downspouts are not appropriate

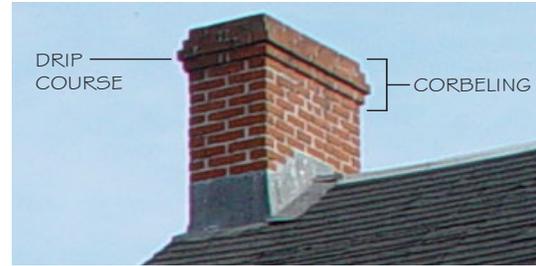
Brick chimney with historic corbeling and drip courses

- ✔ Replacing a chimney should be a historically accurate reproduction of the original chimney and include all drip courses and corbels.
- ✘ Chimneys should not be removed or obscured in any way.
- ✘ Stucco and tar are not acceptable materials for chimney repair.

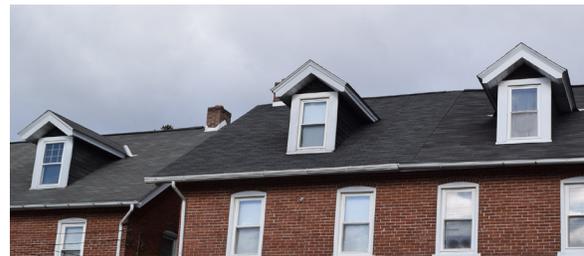
Gable roofed dormers are common in Coopersburg

Dormers can act as both functional additions and decorative features. They can help to increase usable floor space in attics and can add visual interest to roofs. When considering use and placement of dormers in the district, new dormers should be compatible and appropriate for the building and streetscape.

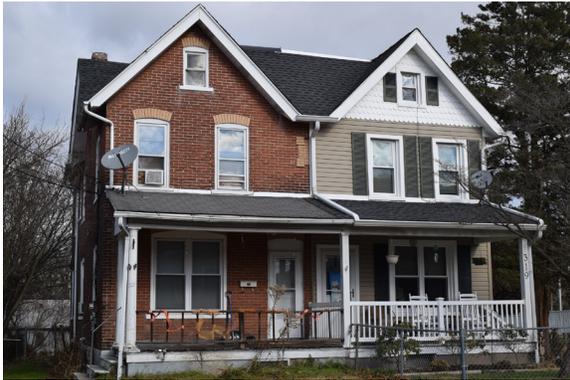
Typical rowhouses featuring brick and wood siding

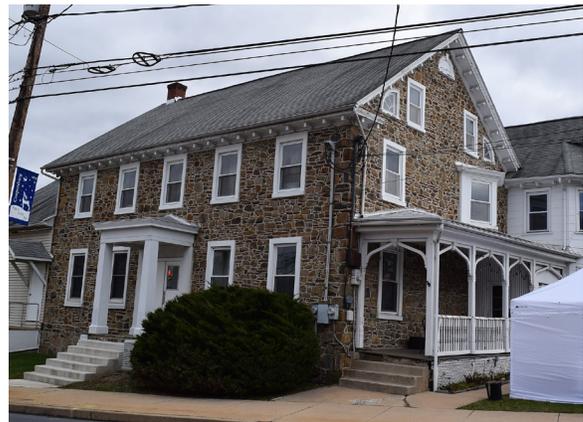
Stone masonry constructed building on Main Street

Stone and brick masonry construction are the most common construction methods for residential and commercial buildings in Coopersburg. In most cases, the masonry was left unpainted and unstuccoed. The removal of existing brick or stone coat may be difficult and can cause further damage to the original masonry. If there is simulated brick or stone facing tightly adhered to historic masonry, the facing should be maintained.

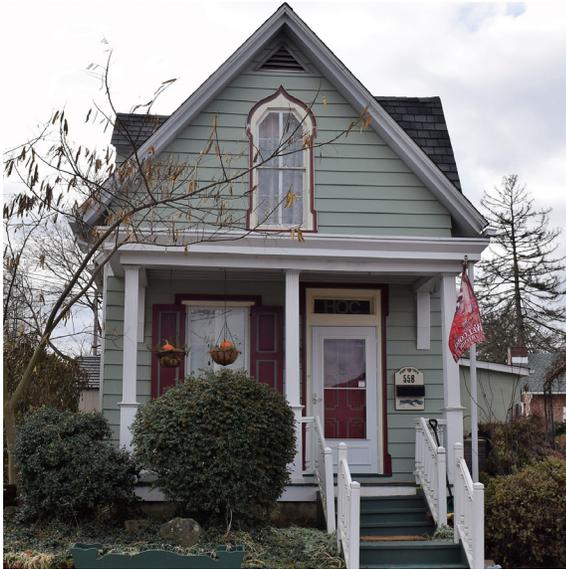
Historic wood-sided cottage

Although the majority of the historic buildings in Coopersburg feature brick or stone masonry, wood siding is found on many residential and commercial buildings. It is also very common on additions constructed at the rear or sides of all styles of buildings.

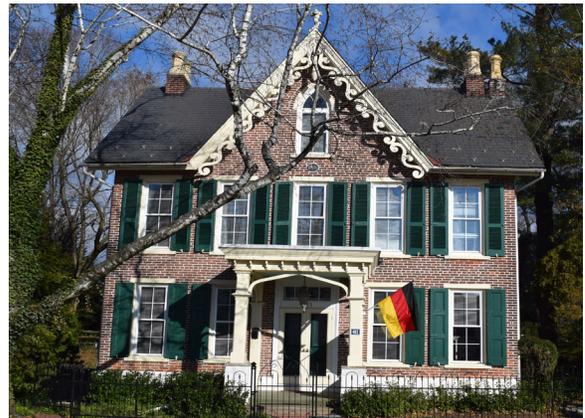
Victorian Eastlake style detailing

The terms trim and detailing refer to corner boards, window and door surrounds, brackets, moldings and other decorative architectural features. Wood trim and detailing should be repaired or replaced to match the historic appearance.

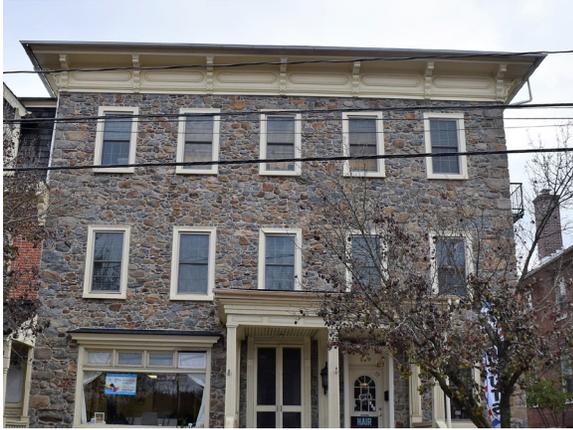
Italian Renaissance Revival style cornice on Main Street

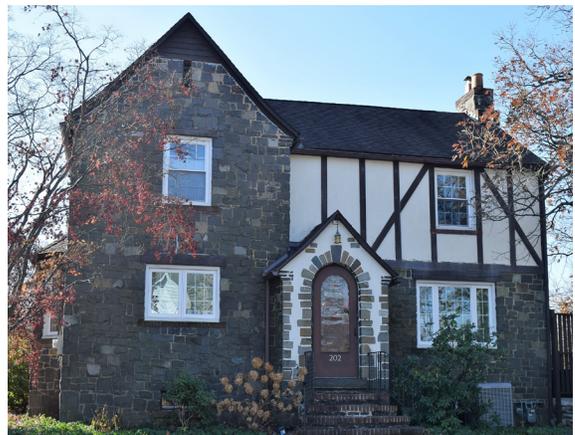
Unique Tudor Revival-style cottage with half-timbering, stucco and stone siding

There are instances where historic buildings may contain architectural features that are original to the building and unique to Coopersburg. It is highly encouraged to retain these unique historic features. The replication of features through historical evidence or photographs and replacement of missing unique features is encouraged. See the Secretary of the Interior's Standards #2 and 5 for reference (pg 13).

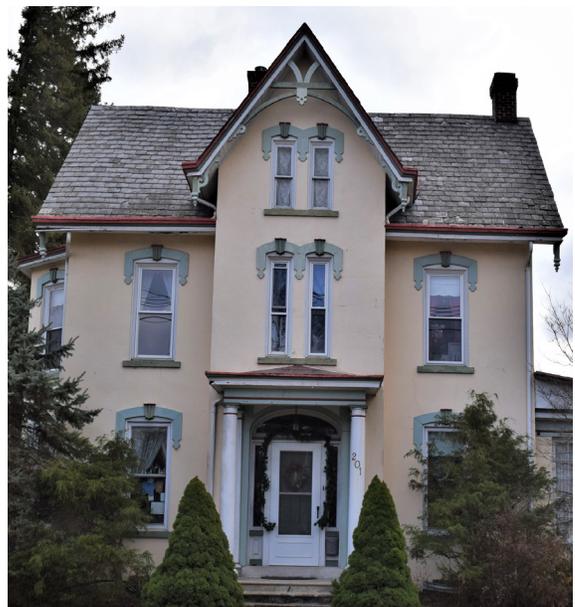
Unique Victorian window trim and detailing

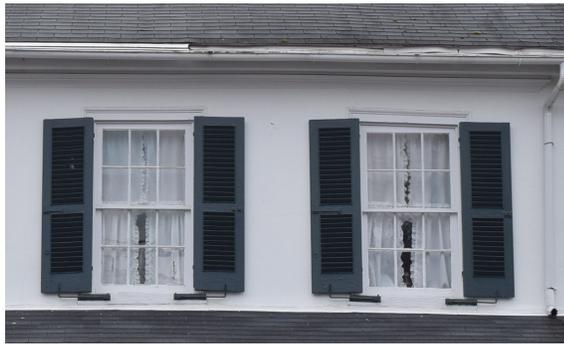
Historic 6 over 6 double-hung windows

Windows typically comprise at least one-quarter of the surface area of exterior walls of most historic buildings. Windows and their trim, shutters, and associated decorative elements, are important character-defining features of historic buildings and are key determinants of their age and style. Double-hung windows are the most common historic window types in Coopersburg.

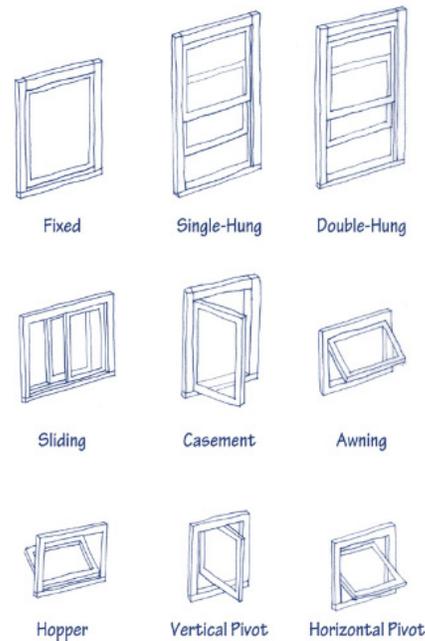
Common window styles  
(Courtesy of Preservation Design Partnership)

Late nineteenth-century architecture, such as Queen Anne and Italianate era buildings, often exhibit windows of various shapes and elaborate frames, trim and casing details and applied ornament. When the Colonial Revival style grew in popularity in the early twentieth century, the use of multi-light windows with narrower frames and casings was prevalent.

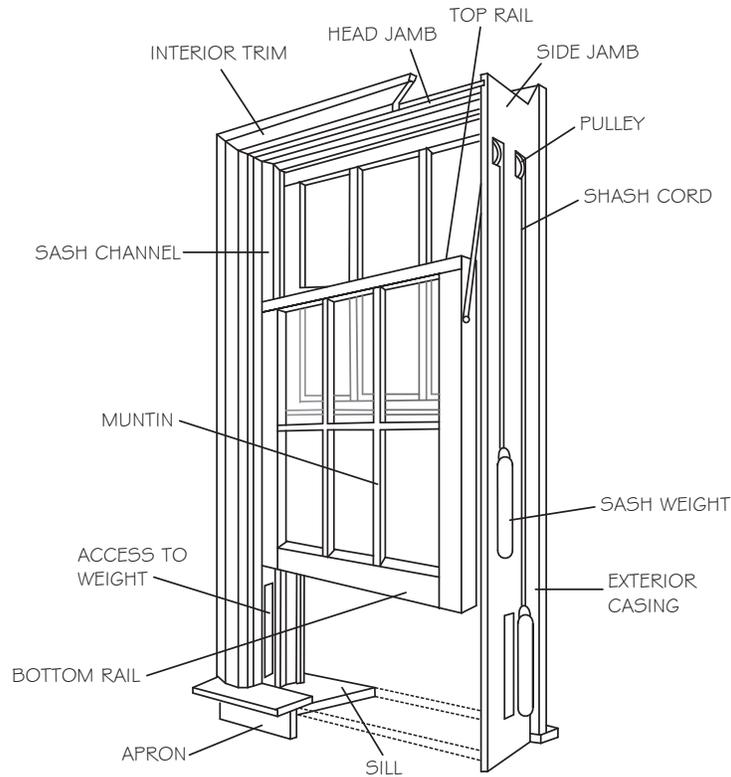
Typical parts of a historic wood-framed, wood sash double hung window (Courtesy of Artefact Inc.)

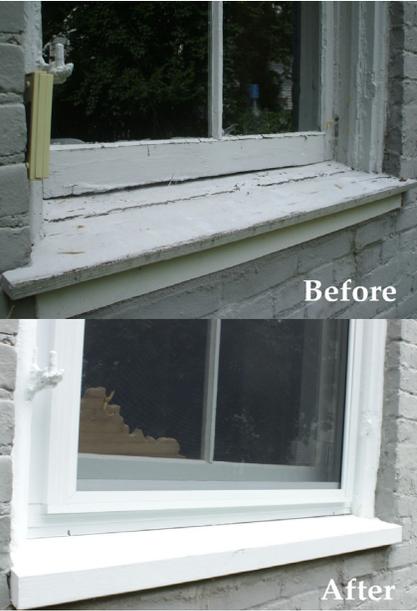
Deteriorated window before and after repair, repainting, and installation of a storm window

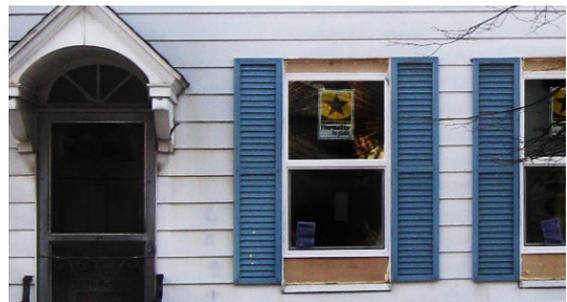
Historic window openings inappropriately infilled

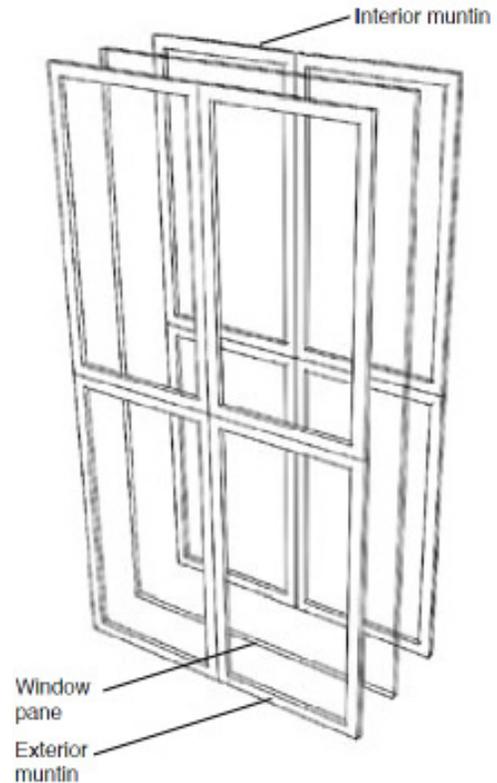
Simulated divided-light windows have a single window pane "sandwiched" between muntins

If the repair of a window is deemed not possible and replacement is required, the replacement unit should match the historic window unit in design, dimension, and muntin configuration. The replacement of a historic wood window with a new aluminum-clad wood or wood composite window should be reviewed for compatibility. In all cases, the appearance of divided lights on a historic window should be retained through the use of simulated divided lights (SDL) on the new window.

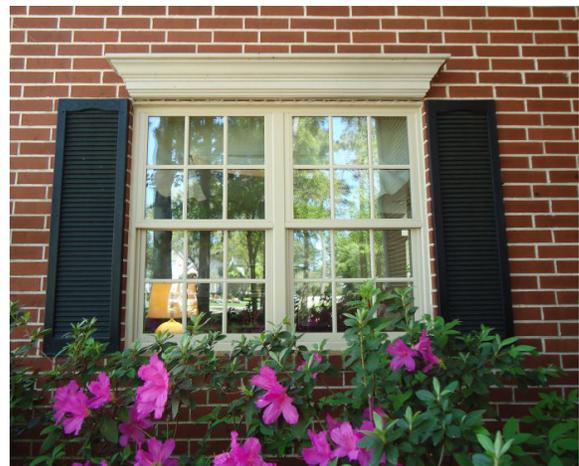
Restored muntins in a 6 over 6 window

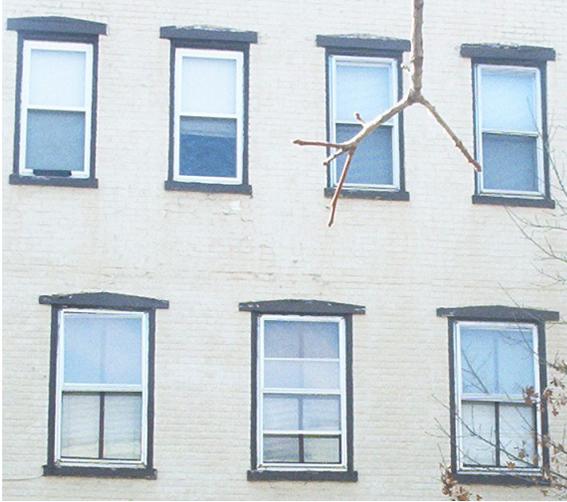
Exterior storm windows

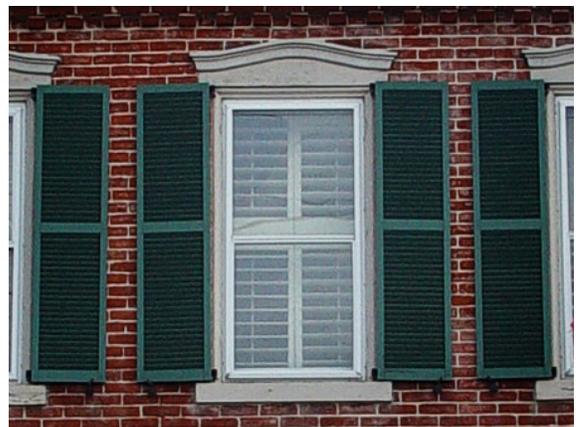
Historic window with exterior aluminum storm window and wood louvered shutters

Historically, shutters were used as window shielding devices. Typical historical shutters feature two types: paneled wood shutters on the first story to create a solid barrier when closed, and louvered wood shutters on the second story, used to regulate air and light. Existing historic shutters (paneled or louvered) should be preserved and repaired. The installation of new shutters is only appropriate where shutters existed previously. The historic precedent for shutters on a building should be physically evident through surviving shutter hardware, window features, or documented in historic photographs. The appropriate size of shutters is one-half the width of the window sash.

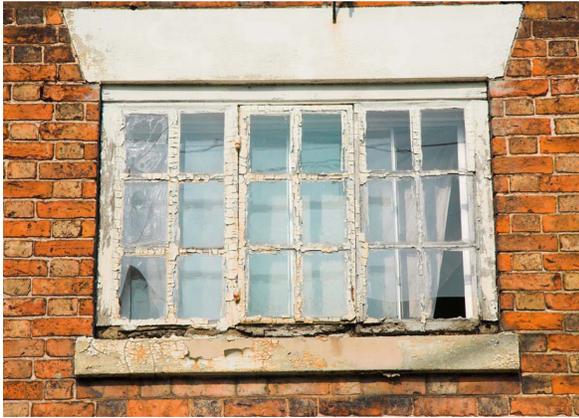
Deterioration typically starts at the sill. Peeling paint allows in moisture which causes the wood to rot.

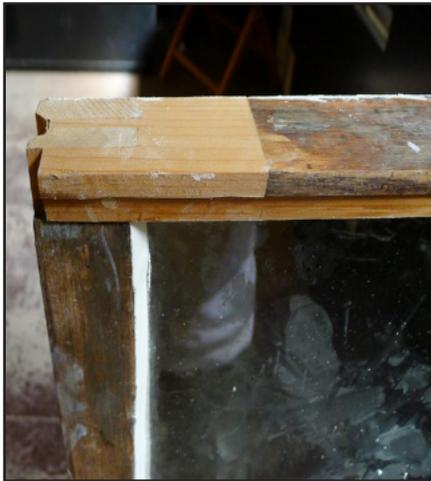
Historic wood window with replaced 'Dutchman' and new glazing putty. An advantage of historic windows over modern units is easy reparability.

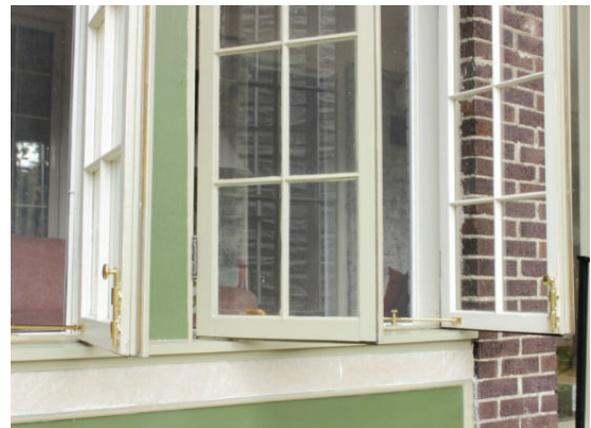
Restored wood casement windows

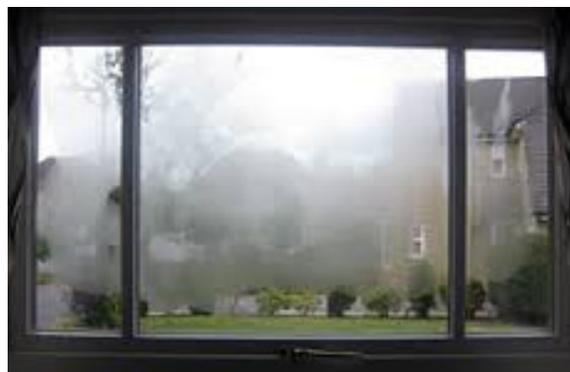
Window with condensation due to faulty gasket seal

Double glazing or insulated glass, used in most new window systems, is made up of an inner and outer pane of glass sandwiching a sealed air space. The air space is typically filled with argon gas with a perimeter seal. This perimeter seal can fail in as few as 10 years, resulting in condensation between the glass layers, necessitating replacement to allow for clear visibility (See image at top right). Many of the gaskets and seals that hold the glass in place also have a limited life span and deteriorate in ultraviolet light.

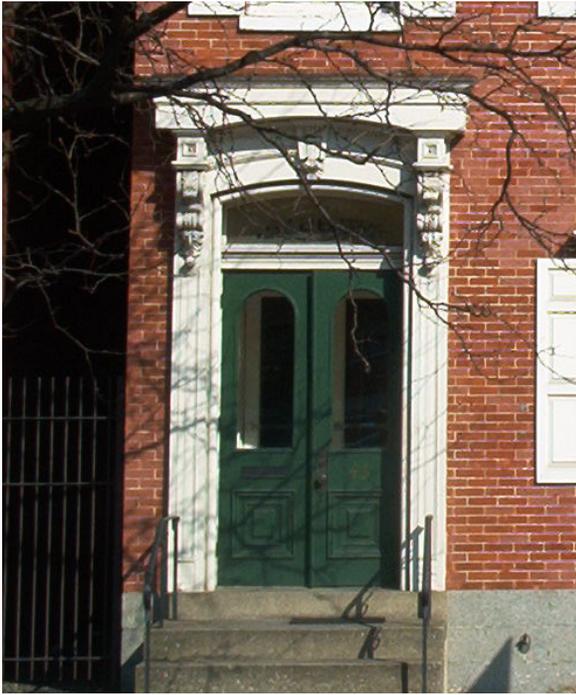
Partially-glazed, wood-paneled double door with transom

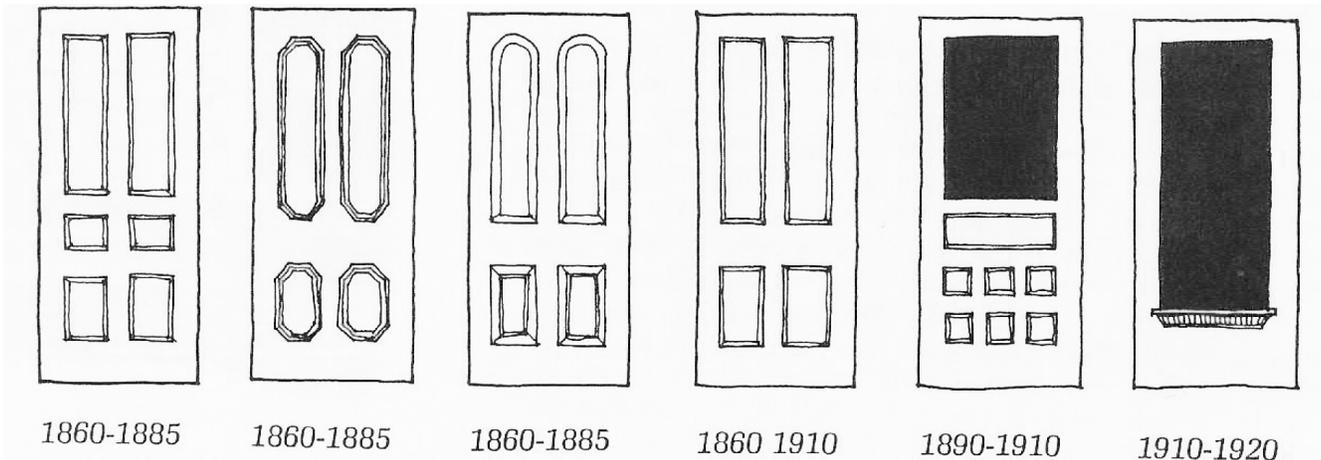
Historic doors and their time periods (Courtesy of O.A.P.A Inc.)

By the 20th century, new door types emerged, including flush wood and metal doors and fully glazed wood-framed doors, and glass doors. Other types of doors include hinged, sliding, double or paired, bi-fold, batten, pocket, and overhead. Common door types are defined in the Appendix and illustrated on the following page.

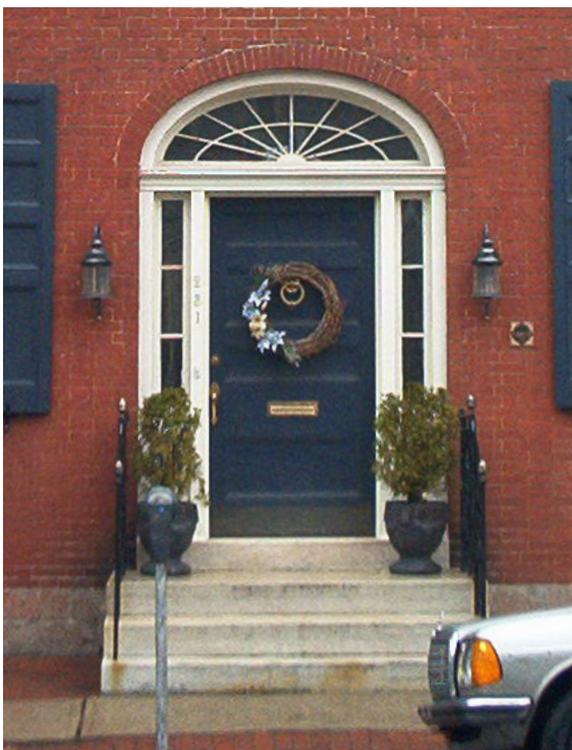
Wood-paneled door with multi-light arched transom

The repair of a historic door is recommended over replacement. The material, size, panel configuration and glazing pattern of a door should be preserved and selectively repaired. Unique features of doors, such as transoms, sidelights, stained glass, leaded glass, or cut glass should be preserved and repaired.

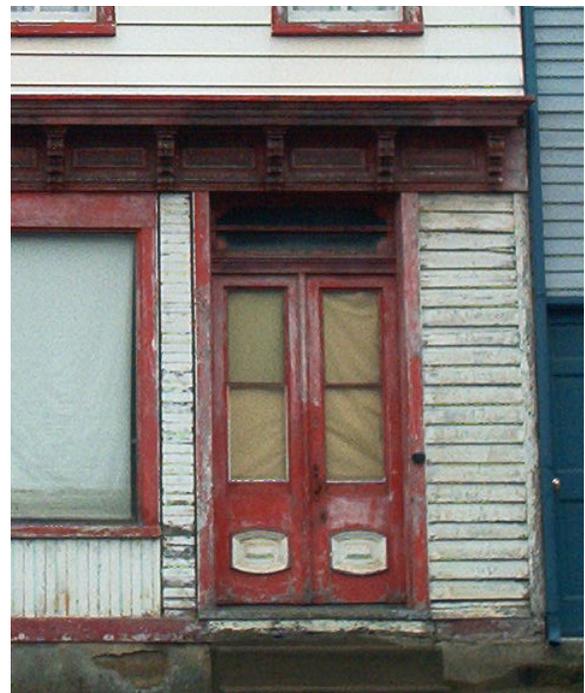
Wood rot and peeling paint are common issues. Minor repair and maintenance can prolong the serviceable life of most historic wood doors.

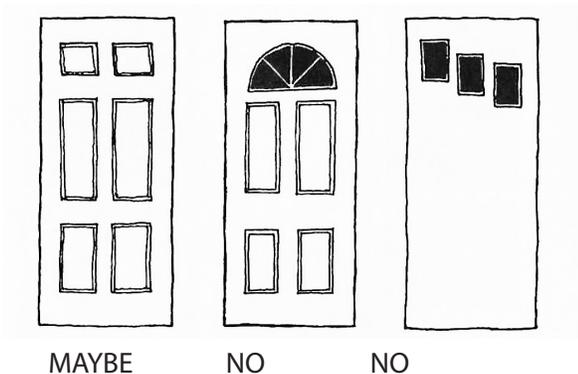
Appropriate and inappropriate door styles  
(Courtesy of O.A.P.A Inc.)

A replacement door should be sized to fit the existing opening and should match or be of an appropriate material, style, panel and/or light configuration. Typical styles and configurations appropriate in historic Coopersburg include 4 or 6 panel wood doors, partially and fully glazed doors (single and multi-light) with light configurations appropriate with the style and configuration of the existing windows or other doors.

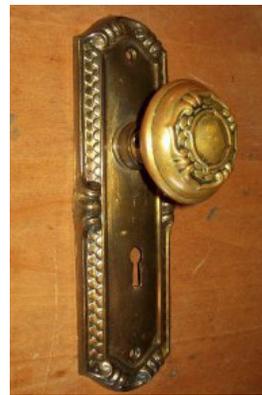
1910-20s era door knob

Replacement in-kind of historic door and window hardware is encouraged when possible. Otherwise, period appropriate hardware should be selected. Combination locks and similar style hardware are typically not appropriate.

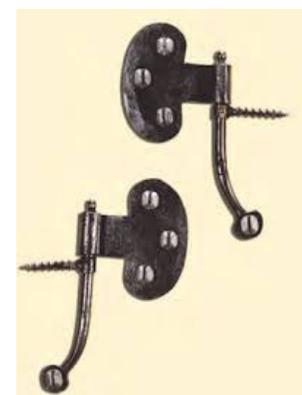
18th c. iron hinges

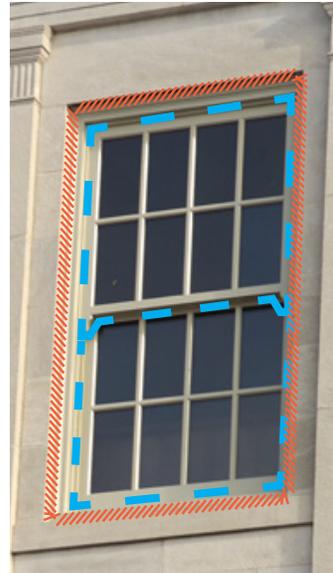
— Recommended weatherstripping locations:

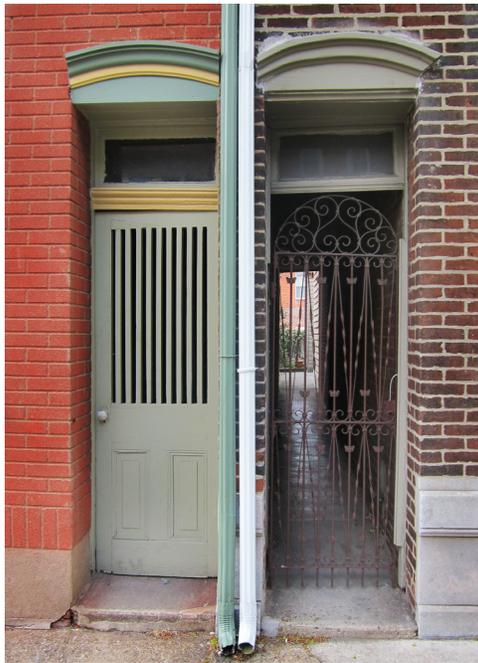
Alleyway door and gate

Typically, exterior access to building rear entries, especially in rowhomes, was historically provided by means of a narrow, often covered walkway, or grocer's alley at street level. In later rowhomes, the basement level was accessed via a short flight of steps. Grocers would typically deliver fresh food and milk to rear kitchen doorways. Two types of alley or rear doors were popular, including wooden doors (either solid or with grilles for air circulation) and iron gates. As with other doors, repair of historic alley doors is strongly recommended.

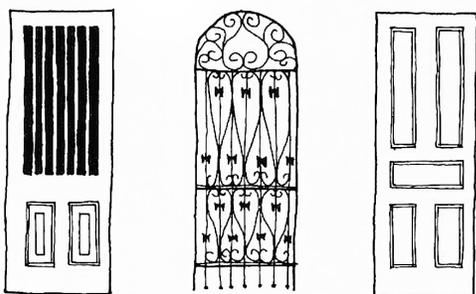
Typical rear door types (Courtesy of O.A.P.A Inc.)

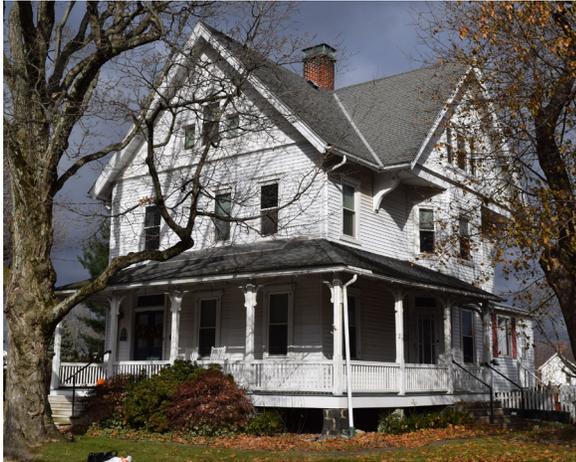
Farmhouse wraparound porch

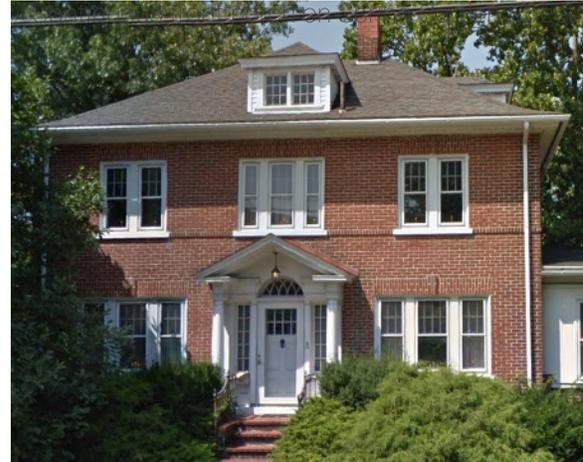
Typical front entry stoop on Main Street

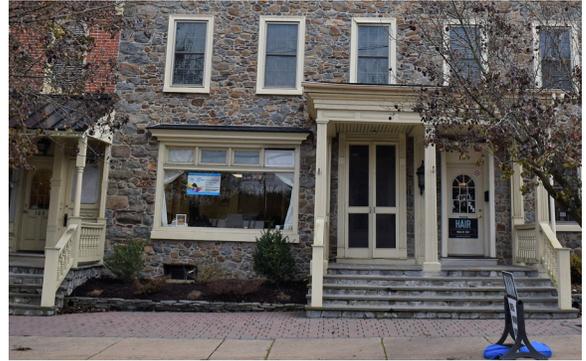
Historic commercial storefront on Main Street

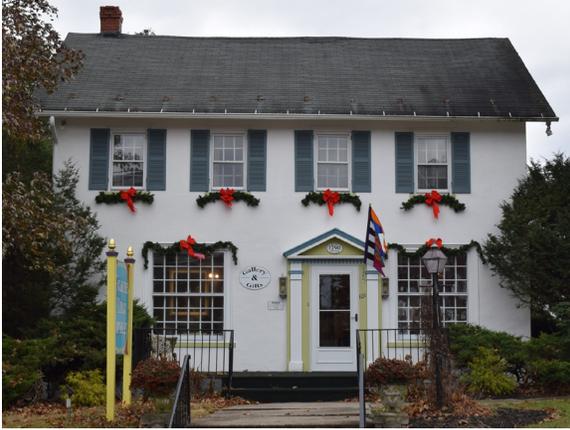
Storefront with large divided light windows on Main Street with apartments above

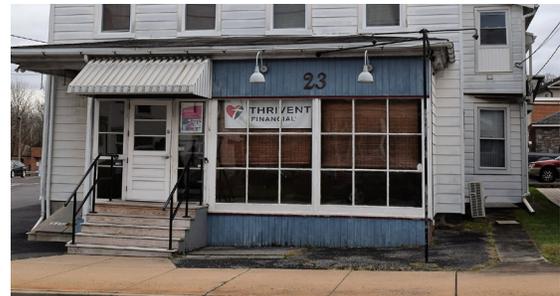
Altered historic commercial storefront with large plate glass windows on Main Street

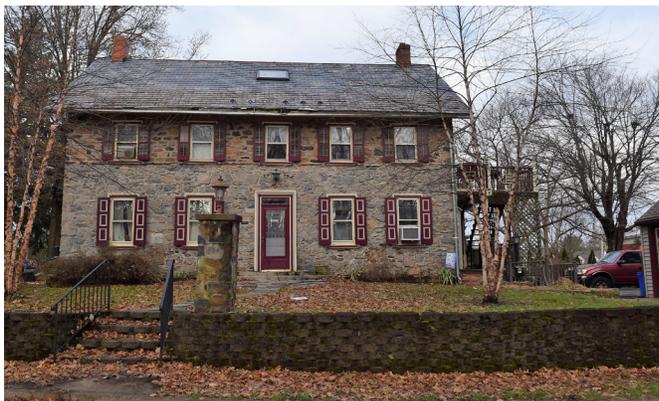
Stone retaining wall

While retaining walls are often built out of structural necessity, retaining walls should still be compatible with and contribute visually to the character of the historic district. Historic masonry retaining walls should be preserved and repaired. The new construction or replacement of retaining walls visible from the public right-of-way should be constructed of traditional masonry materials.

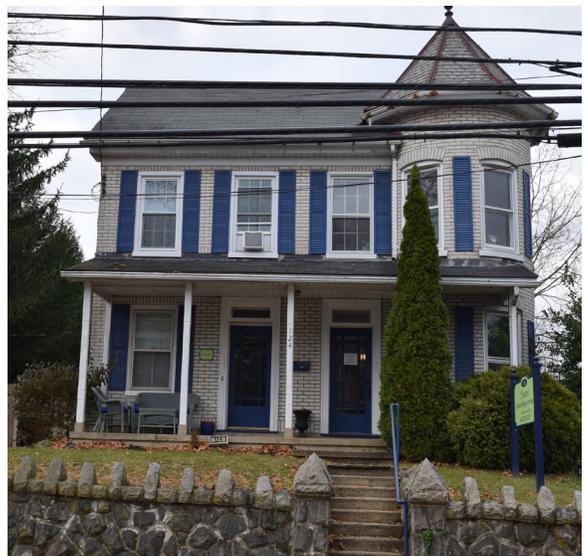
Typical raised front yard separated from street by stone wall with central stair

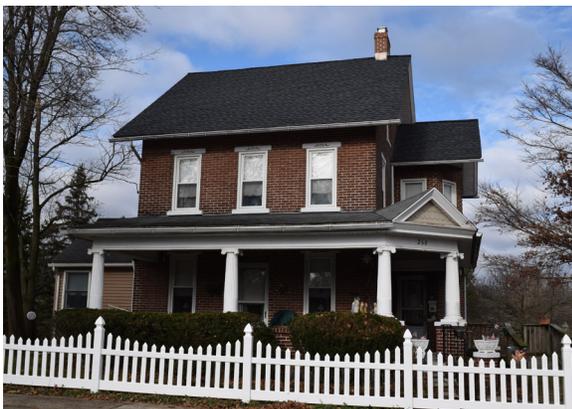
Low Picket fence

Fences along front yards, streets and sidewalks should not obscure the view of the front yard or building. Ornamental iron fences often are recommended as they provide the best balance of transparency and separation. Existing ornamental iron fences should be preserved and repaired. A low wood picket fence is also an appropriate fence style. Gates should not swing onto the public sidewalk. Fences that provide more privacy such as vertical board styles are acceptable for rear or side yards. If additional privacy is desired in a rear or side yard and an ornamental iron fence already exists, a wood fence may be installed behind the ornamental iron fence.

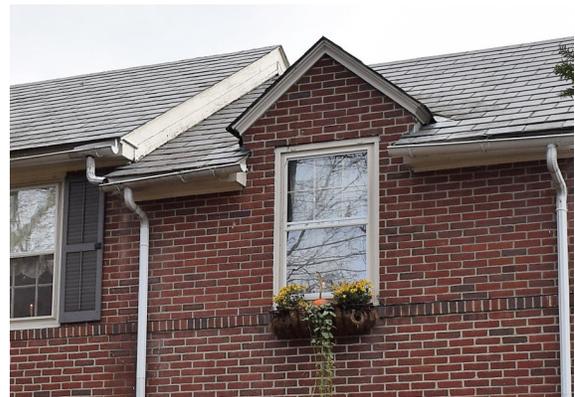
Facade with second story window box on Main Street

Planters and window boxes, although not always original historic features, can greatly enhance the visual character of a building when considered properly. Moveable landscape planters made of red clay, wood or tinted concrete are recommended. Moveable planters should relate in size and scale to their location. Window boxes should be simple in design and should match the color of a building's trim or shutters. Window box sizes should match the width of the window opening. Window boxes should be mounted in a way that does not damage historic masonry.

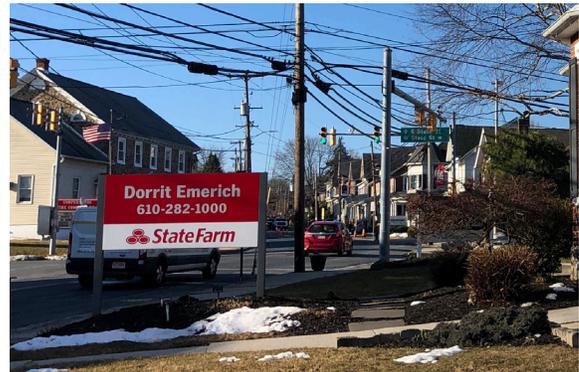
Freestanding sign on Main Street

Wall and freestanding signs are the most common types of signage found in Coopersburg. These signs are single-sided and mounted parallel to and generally flush with the wall of a building.

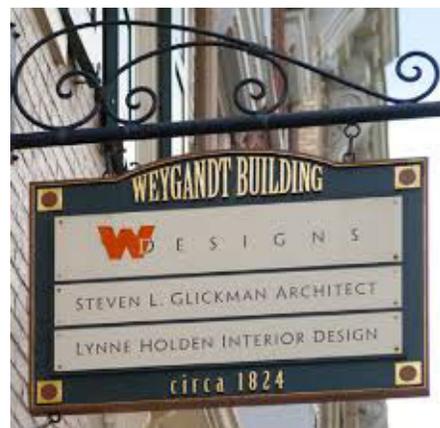
**Perpendicular projecting or blade signs** are generally two-sided and suspended from an iron or metal bracket that is mounted perpendicularly to a building face or architectural feature.

Perpendicular projecting sign

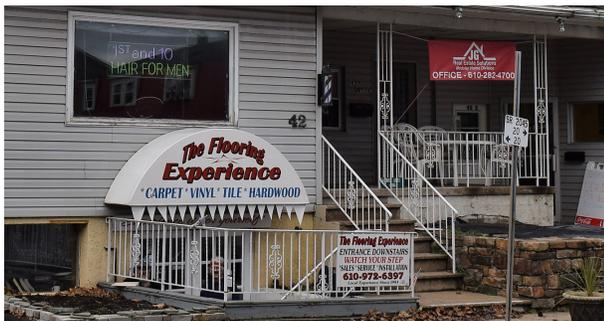
A basement storefront awning on Main Street

Awnings are a historically popular means of sheltering an entrance, advertising, and protecting merchandise from excessive sun exposure. Awnings can be fixed or retractable, and project at a continuous angle away from the face of the building on a metal frame, terminating at a skirt or valance. Fixed awnings can be either open or close-sided, while retractable awnings are open on both ends. The most appropriate awning material is canvas; inappropriate materials include vinyl-coated or glossy fabrics.

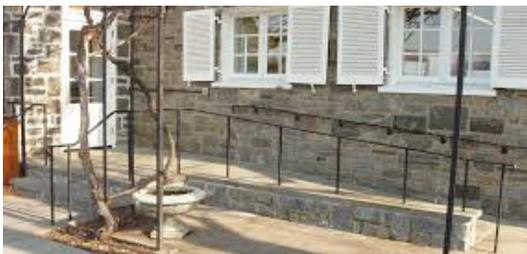
Stylistically compatible ADA ramp

The construction of ramps and installation of lifts are some of the most visible alterations and should be located on secondary facades whenever possible. If ramps or lifts are required to be located on a primary façade, they should be configured to minimize their visual impact on the building or obstruction of unique features. In some cases, ramps or lifts can be incorporated at the interior by modifying door sills and sections of floor.

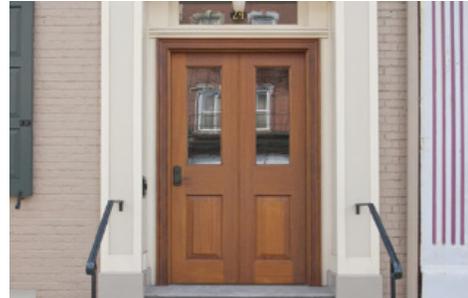
Modified historic door to allow for a wider opening while maintaining the appearance of a paired door

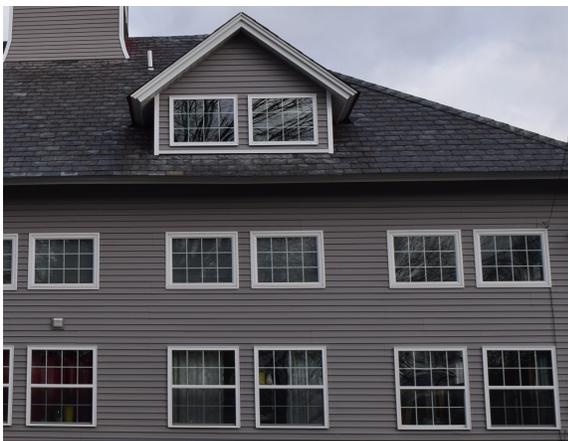
Replaced windows with insulated glazing at the historic stables

Insulated glazing is a modern material that began to be implemented in windows during the 1970s-80s. Today, it is the default type of glazing supplied in new windows and contributes to an increased energy efficiency performance of a new window. Insulated glazing, which is composed of two sheets of glass sandwiching a vacuum-filled layer of argon gas, has a limited lifespan due to potential seal failure. When the seal fails, the space between the two layers of glass will fill with air and condensation will occur obscuring the view through the window (See an image of this in **Chapter 5. Windows**). When this occurs, the glass, and sometimes the entire window, should be replaced. One of the advantages of maintaining historic windows and installing storm windows to improve insulation is a longer overall lifespan than that of new windows.

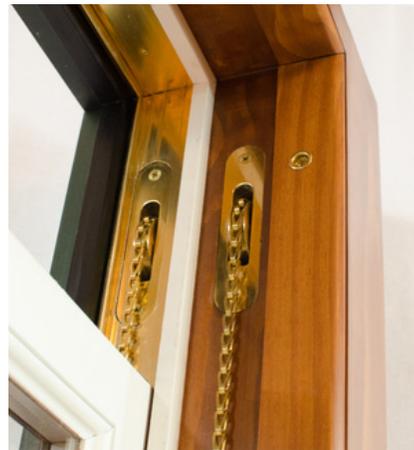
Restored historic wood window chain

Although the list of priorities recommends window replacements be one of the last upgrades to consider, it is often one of the first items on many homeowners' lists to improve their home's energy efficiency. Historic wood windows with weights and ropes (or chains) can often be easily repaired, properly weather-stripped and caulked, and made more energy efficient with the installation of an interior or exterior storm window. The resultant window system retains both the character of the historic windows and the higher quality of historic wood that is more resistant to rot than new wood or wood composite materials. Typically, historic wood windows perform almost equivalently in terms of energy efficiency as compared with a new, insulated glass window.

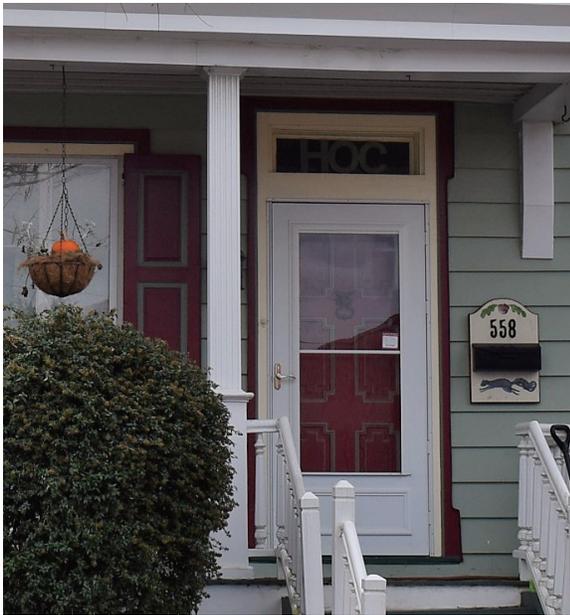
Fully glazed outer storm door with a historic wood-paneled door visible behind

Historic wood doors should be treated in the same manner as historic windows. Solid wood doors are good insulators. As described in **Chapter 6: Doors**, to improve a door's energy efficiency, it should be weather-stripped and caulked. If the home has an interior vestibule with a door, the installation of a storm door is usually not necessary and adds little to the energy efficiency of a house. Where interior vestibules do not exist, exterior storm doors will help create a more efficient seal, but it is recommended that a fully glazed storm door be used so as not to obstruct a view of the historic wood door.

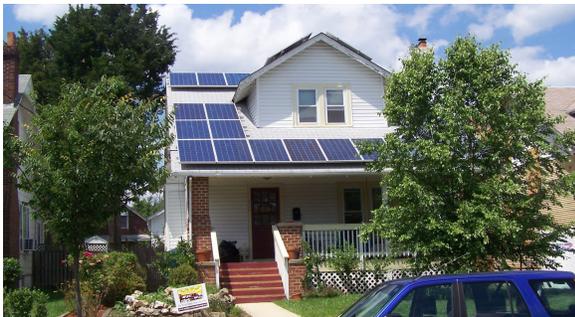
Inappropriate installation of solar panels

On sloped roof structures, solar devices should be mounted on rear or side roofs that are part of secondary facades. The solar panels should be flush mounted on sloped roofs if possible.

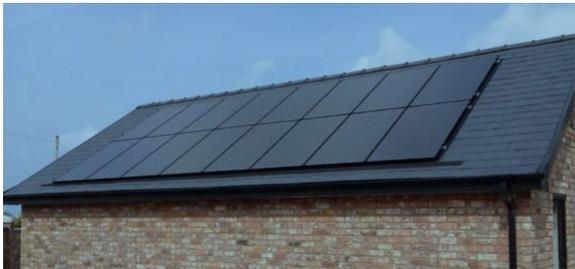
Conforming solar panels on a secondary roof

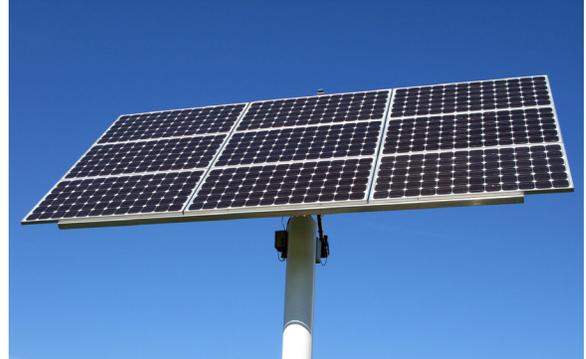
Ground mounted solar panel

If solar devices are located on the ground, they should not be visible from primary streets or other public access routes.
