# HISTORIC COOPERSBURG DESIGN GUIDELINES

RESTORING, MAINTAINING, AND PRESERVING THE  
HISTORIC CHARACTER OF COOPERSBURG

BOROUGH OF COOPERSBURG, PENNSYLVANIA

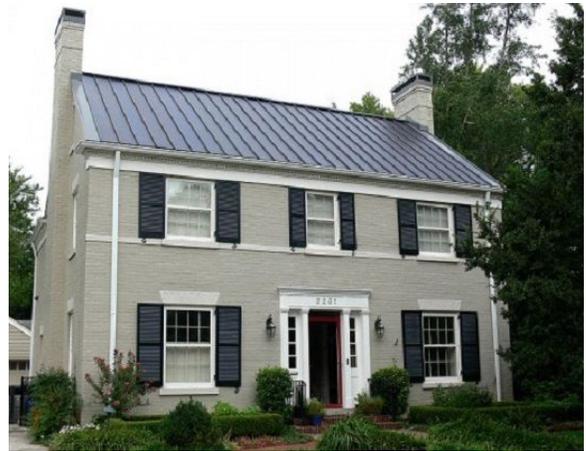
Example of a thin film solar panel system on a 1930s house with a standing seam metal roof

Certain types of solar installations can be subtly integrated onto standing seam metal roofing systems. These systems may be acceptable on sloped roofs on primary facades if a standing seam metal roof is historically compatible with the style of the building or house.

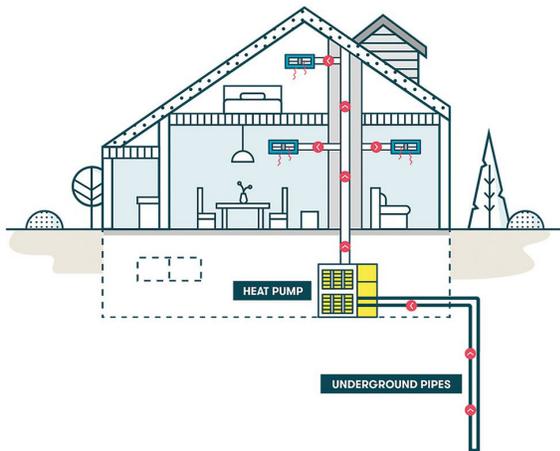
Diagram of geothermal heat pump system  
Source: Kramer Service Group

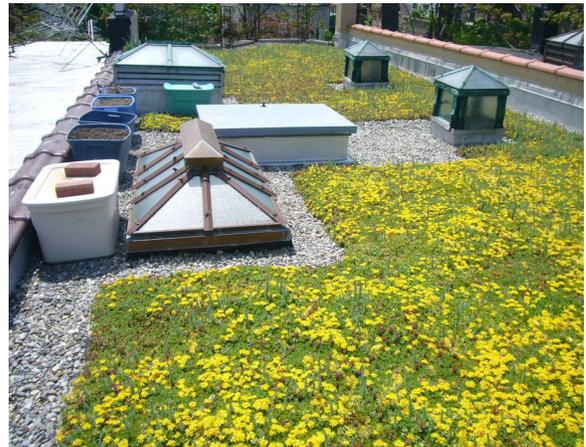
Green roof on a historic flat building roof  
Source: iGrownews

However, the impact of increased structural loads on historic building roofs, added moisture, and potential for leaks must be considered before installing a green roof. A green roof is compatible on a historic building only if the plantings are not visible above the roofline as seen from the ground or primary right-of-way below.

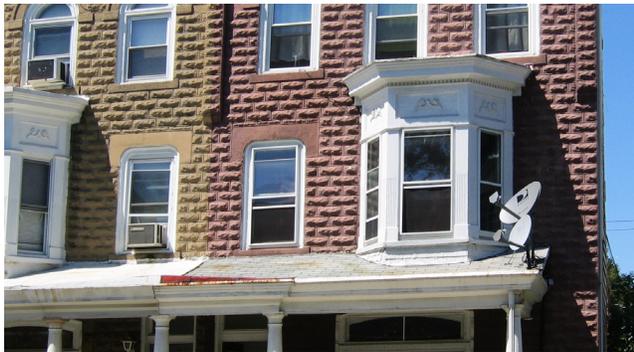
Less appropriate placement of a satellight dish

- ⚠ Equipment such as satellight dishes should be mounted on roofs less visible from the public right-of-way when possible
- ⊘ Mounting mechanical, electrical, and communications equipment and devices on a primary façade or front section of a roof is discouraged

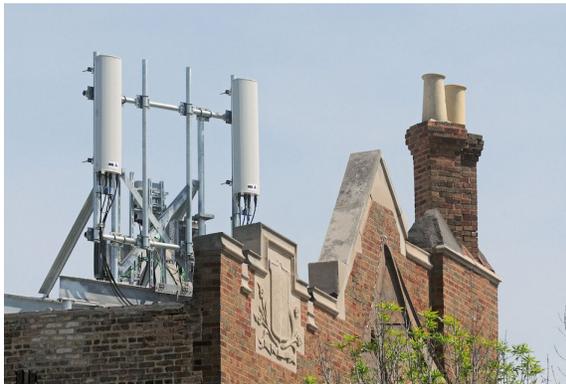
Inappropriate placement of a cellphone tower on a historic roof Source: MySuburbanLife

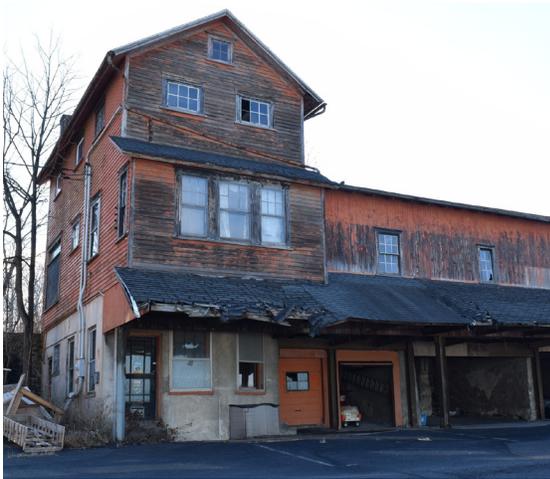
Deterioration of a historic building off Station Ave.

Emergency repairs are considered to be repairs that are time sensitive for the continued habitation of a structure or for the health and safety of its occupants and others. If emergency repairs are needed, the Borough of Coopersburg should be contacted. Prior to emergency repairs being performed, work should first be approved through an emergency on-site review by the Building Inspector. The conclusion of this meeting will result in a prescribed approach for which the building inspector may issue a building permit for work strictly limited to correcting the emergency conditions.

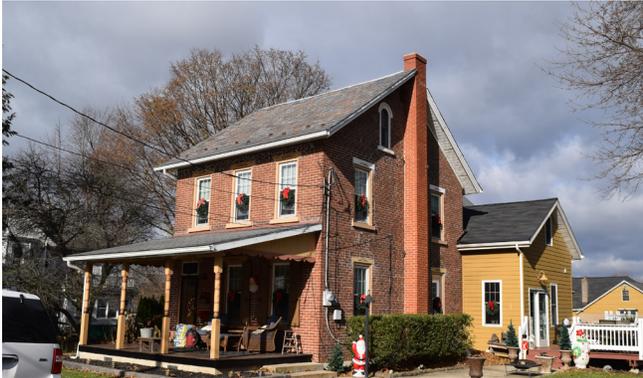
Appropriate wood frame addition to side/rear of historic brick masonry house

While it is important for the borough of Coopersburg to continue to evolve, the design of new buildings and additions to historic buildings must be carefully considered. New buildings and additions should be compatible with other historic buildings and the historic district. New construction that is inspired by traditional forms and detailing is historically appropriate, although contemporary design may also be approved if the massing, size, and scale are compatible with surrounding buildings and the streetscape. It is important to understand that literal replication of historic styles is not appropriate as stated in **Secretary of the Interior's Standard #3**. Additions should be located on secondary and rear facades and should not diminish, obscure, damage, or destroy the building's historic character.

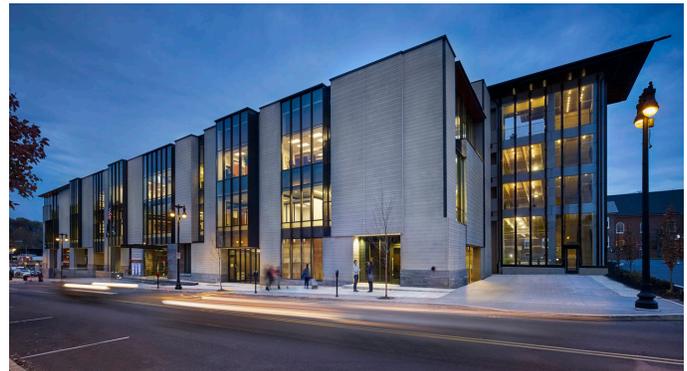
A good example of a contemporary long building that has been divided into smaller sections of solid and transparent features (Easton City Hall located in Easton’s historic district)

Designs for wide buildings (in excess of 40'-60') should be broken into a series of masses, solids, and voids that are compatible with those of the adjacent buildings. While buildings more than two or three stories taller than surrounding buildings are typically not encouraged, the topography and siting of a particular parcel (i.e. corner lot or base of a hill) could potentially accommodate a taller building if the massing, detailing, and orientation control the perceived scale of the building in the streetscape.

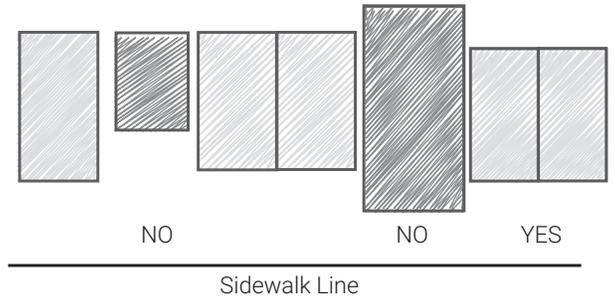
New buildings should match the setback distances of adjacent buildings on the street

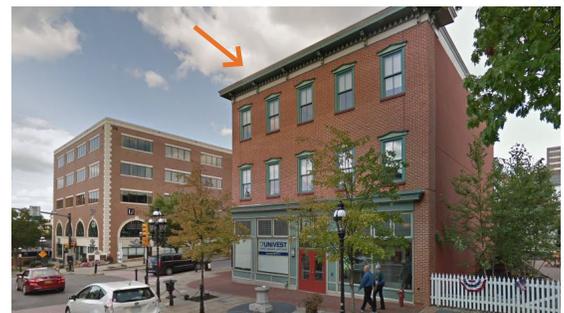
Compatible reconstruction at southeast corner of Main and Broad streets in Bethlehem following a fire in the 1990s (Googlemaps, 2018).

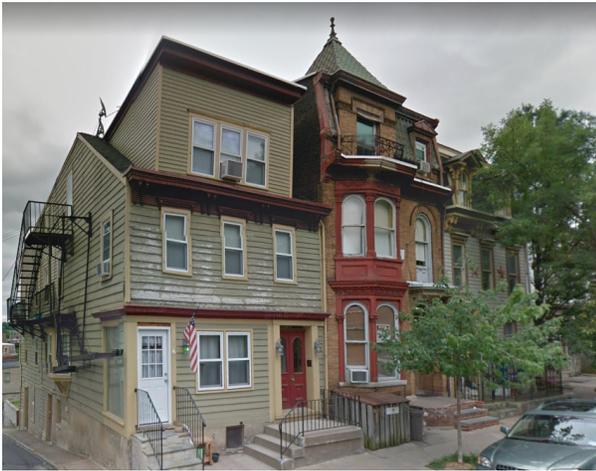
Incompatible scale, roof form, and materials at third story roof addition

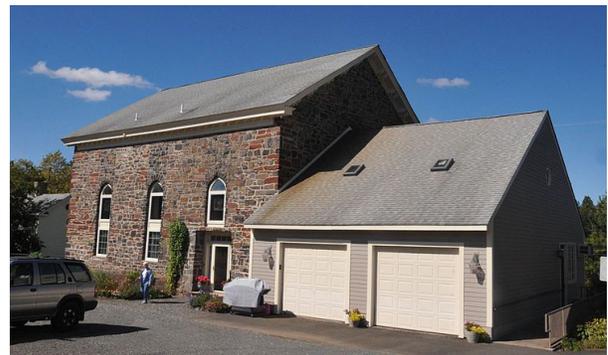
Compatible gable roof forms at a church in NJ

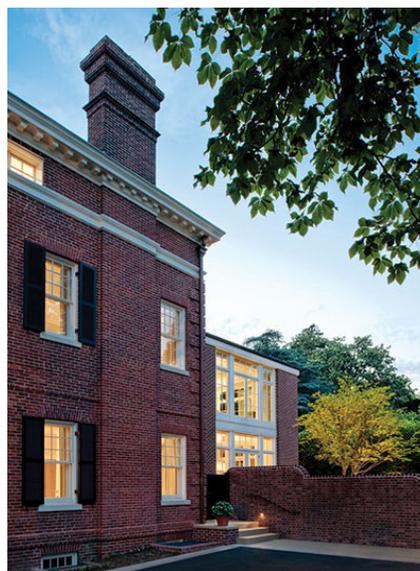
Appropriately located and compatible rear addition  
Source: Preservation Brief #14

New construction and additions provide an opportunity to resolve deficiencies in accessibility that may be present in or around the historic building and not easily resolved through simpler means. Ramps should be located on secondary or rear facades whenever possible.
